## **Do-It Centers**

Matched pair analysis can effectively identify the differences in value of comparable commercial locations that are traceable to the visibility component. An excellent example of such analysis is provided by the experience of a small, four-store independent chain of home-improvement centers, known as the “Do-It Centers” and located in southern California.

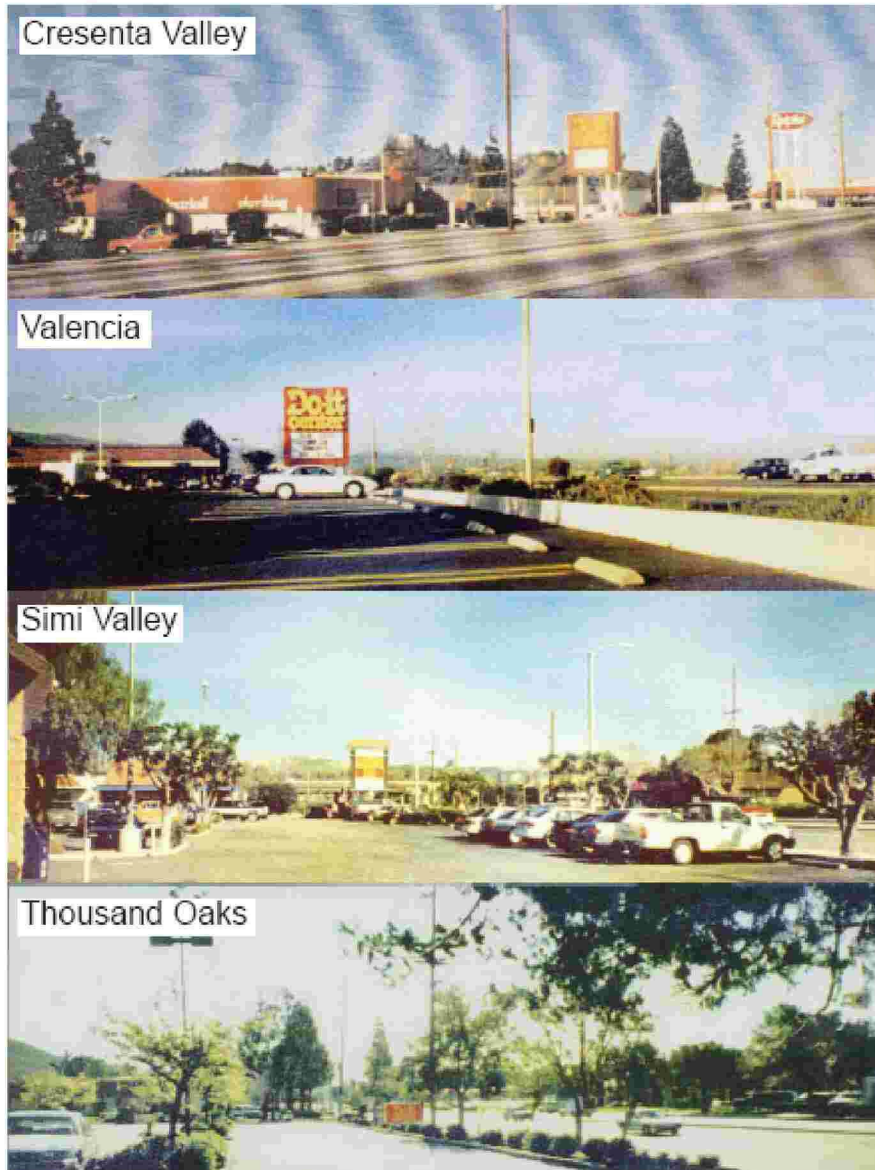
*Matched pair analysis is an effective tool in identifying the precise features of a property that affect value. These four "Do-It Centers," all located in southern California, carried the same products. The differences were pared down until a measurement of the financial impact of the local sign code could be made. The findings showed that effect was significant.*

Cresenta Valley had a liberal sign code which allowed the chain owner to place a large storefront wall sign over the main entrance and border wall signs listing products (housewares, paint, electrical, and plumbing) along the sides of the building. A large, double-pole free-standing sign that included a variable message board was erected adjacent to the street.

Valencia’s code was similar, and the owner was able to place large wall signs over the main entrance and along the sides. However, in contrast to the Cresenta Valley location, the visibility of the freestanding sign was somewhat blocked by a landscape median between the street and the sign, as well as a parking barrier in front of the sign, which was also somewhat shorter in height.

Simi Valley had a much more restrictive sign code; consequently, the site’s storefront signage was considerably smaller, limited to narrow border wall signage. Although its freestanding sign was tall and close to the street, the store was required to share the sign with other businesses.

The sign code in Thousand Oaks was the most restrictive of the four. The site’s storefront signage was limited to a small entrance sign and two small “hanging” signs at either end of the building. The freestanding sign was located on a landscaped strip next to the road, but the size limit of 36 square feet resulted in severe masking of the sign by surrounding foliage.

Following the remodel, and despite Home Depot's presence, the Cresenta Valley store increased its sales by 45% and Valencia by 38%. On the other hand, the Simi Valley store's increase was only 20% and the Thousand Oaks's increase a mere 10%. Further, the difference in sales volume between the Thousand Oaks site and the Cresenta Valley site, which prior to remodel was only 15%, considerably increased. The chain owner had not increased local media advertising, thus the disparate increases in sales volume between all the stores could only be attributed to the availability – or lack thereof – of on-premise signage easily visible and readable to street traffic.
